Concrete Pipeline Systems

Testing of pipe materials' resistance to high-pressure water jetting (Report 1)

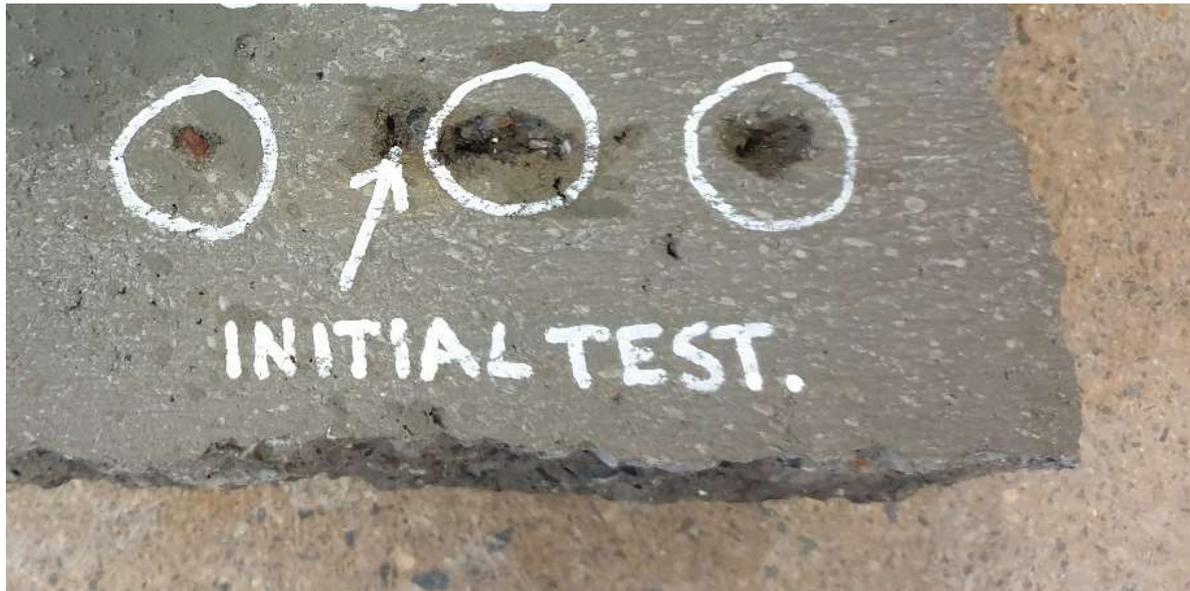
A BPDA member company DN 450 concrete pipe with wall thickness >60mm was tested. After 3 minutes of testing, surface damage was detected at all jetting sites, varying in depth from 3.3mm to 6.8mm. All sites would still pass gauging for maximum surface void size as specified in Draft BS 5911-1:2020.

Figure 1. Sample 1 after testing.

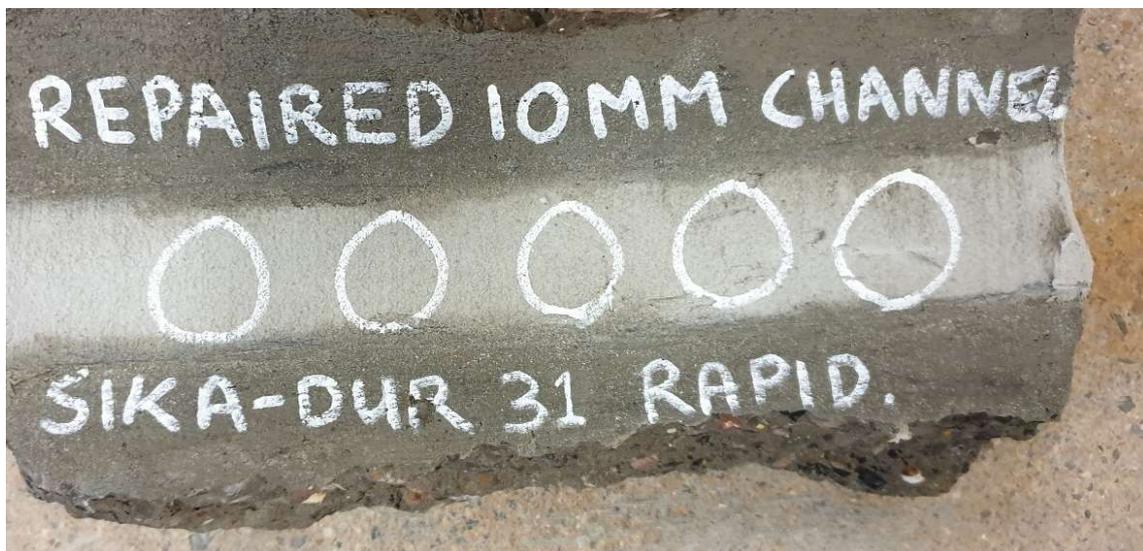
A BPDA member company DN 450 concrete pipe with a repaired 10mm deep x 10mm wide channel¹ was tested. No visible damage was caused by the water jet at any of the jetting sites tested.

Figure 2. Sample 2 after testing.

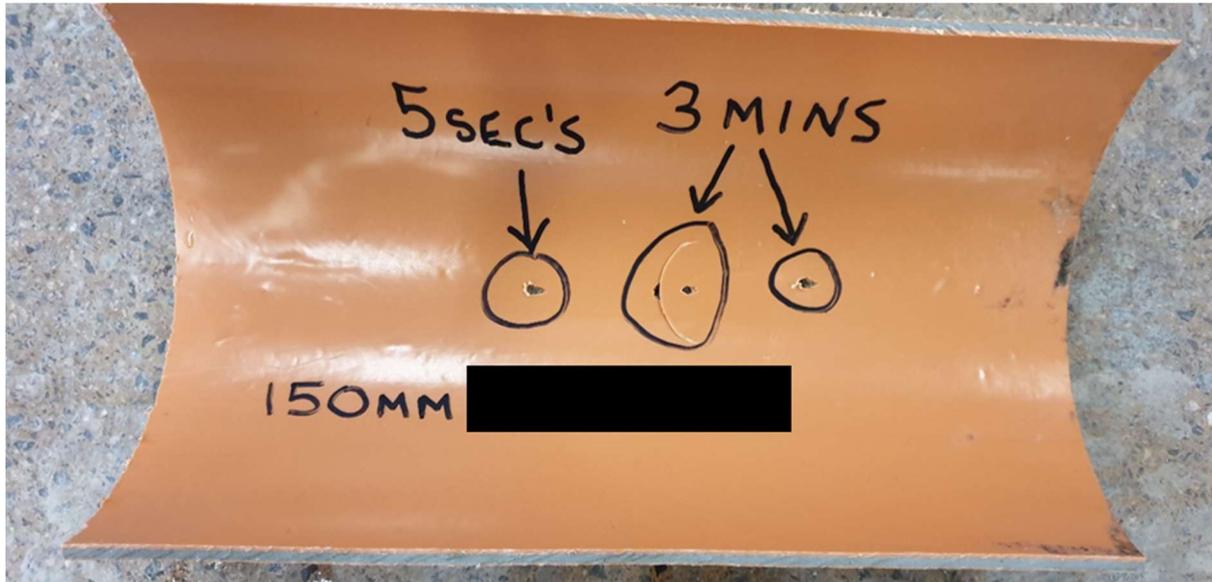
One uPVC pipe type DN150 was tested. The jetting water pierced the surface of all three sites tested after only 5 to 10 seconds.

The jetting water then dispersed through the core material within the wall and raised blisters on the inner surface, allowing the jetting water to escape internally. But water did not pierce

the full wall depth of the pipe after three minutes of test duration. Blister size approximately 50mm in diameter.

Figure 3. Sample 3 after testing.

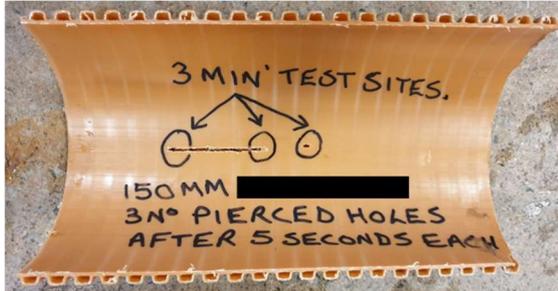
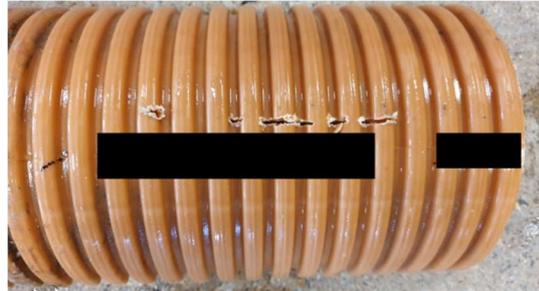
One Double-wall type DN150 plastic pipe was tested. All three jetting test sites pierced the inner surface after 5 seconds and quickly continued to pierce through the full wall depth.

Figure 4. Sample 4 after testing.

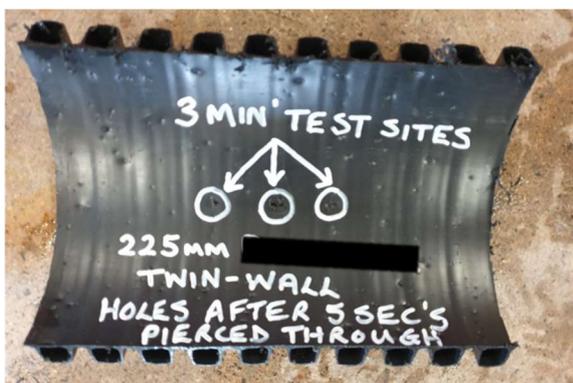
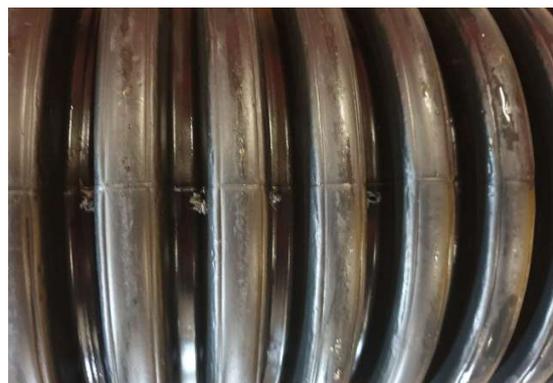
One double-wall type DN225 pipe was tested. All three jetting sites tested pierced the full wall depth of the product after approximately 5 seconds.

Figure 5. Sample 5 after testing.

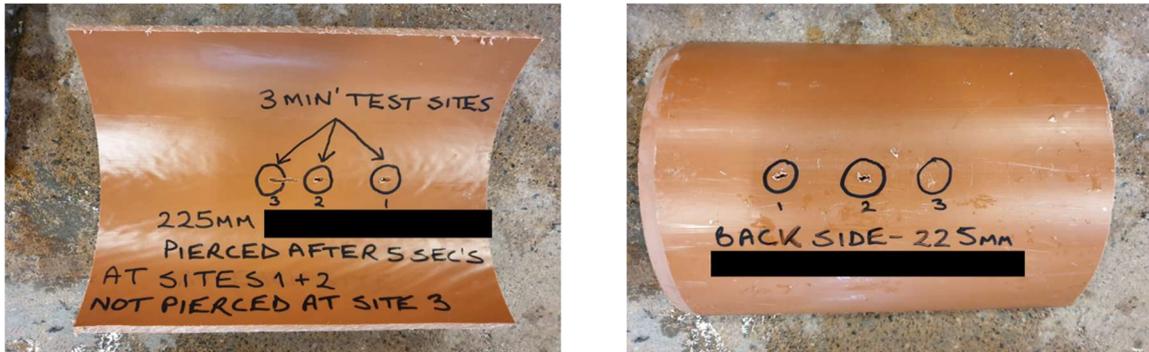
PVC pipe with smooth external & internal surface was tested. All three jetting sites tested pierced the inner surface after approximately 5 seconds and two out of the three sites pierced the full wall depth of the product a few seconds after.

Figure 6. Sample 6 after testing.

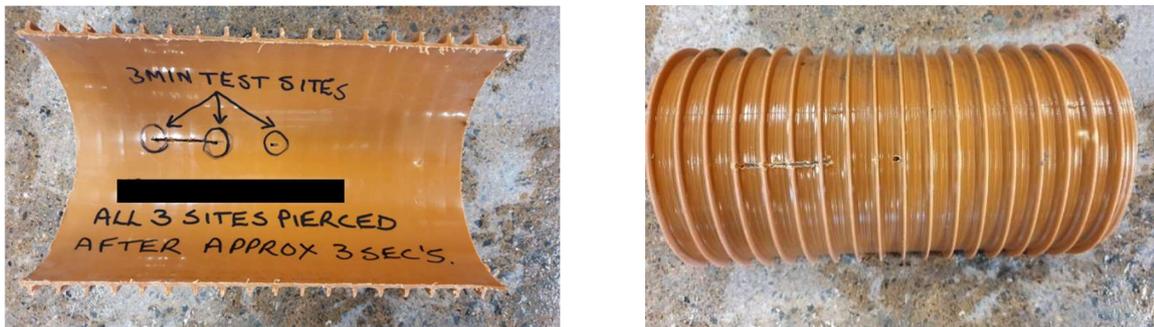
uPVC type DN150 plastic pipe was tested. All three sites tested pierced the inner surface after approximately three seconds and continued to pierce the full wall thickness after several more seconds under the test.

Figure 7. Sample 7 after testing.

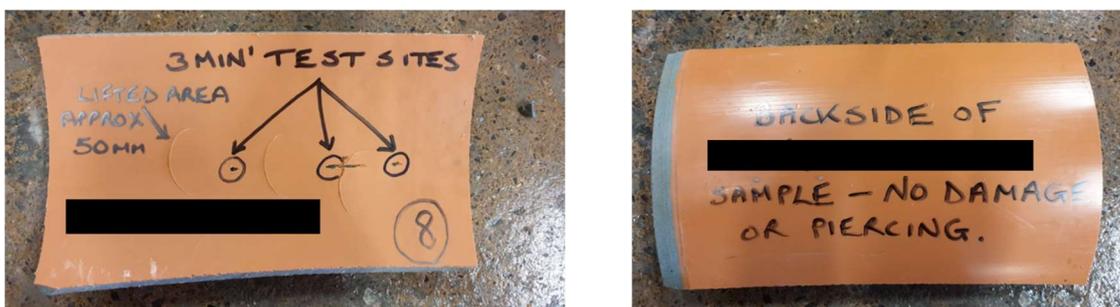
uPVC pipe type DN375 was tested. All three jetting sites tested pierced the inner surface after several seconds. The water jet then dispersed into the inner recycled core material until after approximately one minute of testing. The inner surface material blistered adjacent to each test site, allowing the water jet to escape internally. The blister sizes were approximately 50mm in diameter. No damage was detected in the outer surface of pipe.

Figure 8. Sample 8 after testing.
